# **OPERATING EXPERIENCE WEEKLY SUMMARY**

**Office of Nuclear and Facility Safety**

**May 22 - May 28, 1998**

**Summary 98-21**

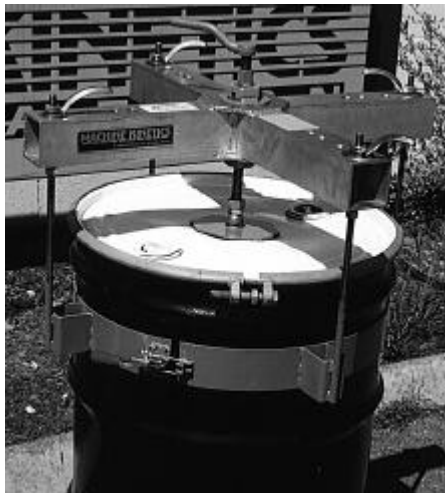
**Figure 2-1. Drum Lid Restraining Device (Courtesy Machine Kinetics Corporation)<sup>1</sup>**

When drum pressurization is suspected, facility managers have a number of options to consider when planning activities to relieve the pressure inside the drums. Drum lid restraining devices may be as simple as cargo net webbing secured over the drum. A commercially available example of a web type of lid restraining device is the Drum Web 5585 manufactured by EET Corporation. Their URL is [www.eetcorp.com](http://www.eetcorp.com). Drum venting devices may be as simple as a non-sparking spike at the end of a backhoe used to puncture the drum lid. When a hazardous release can be expected, the venting should be performed in a high efficiency particulate air filtered enclosure. Figure 1 shows a commercially available drum lid restraining device. Figure 2 shows a commercially available device to remotely vent pressurized drums. Figure 3 shows an enclosed drum venting system developed by the Los Alamos National Laboratory.

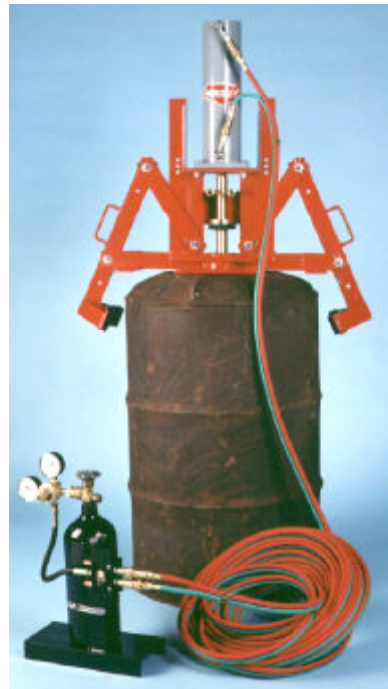
**Figure 2-2. Remotely Operated Drum Venting System (Courtesy Americlean, Incorporated)<sup>2</sup>**

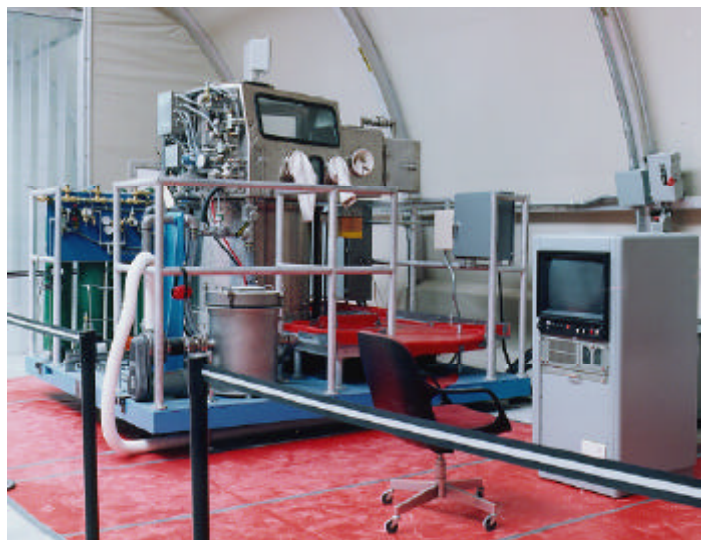
**Figure 2-3. Drum Venting System (Courtesy Los Alamos National Laboratory)<sup>3</sup>**

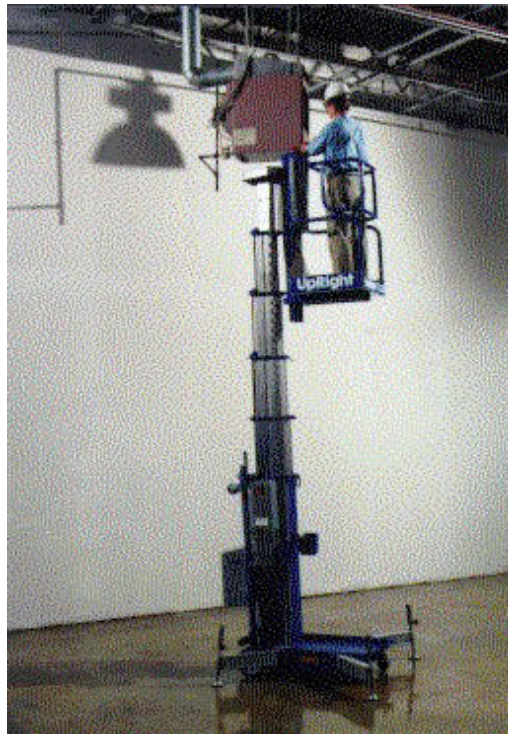
Facility management procured the man-lift (classified as a manually propelled elevating aerial platform by OSHA) for use by various craft workers at the facility. The man-lift, as shown in Figure 4-1, is designed for one worker, who occupies the platform and controls its movement. It is equipped with four ports designed for the insertion of outrigger beams (see Figure 4-2). Each port has an interlock switch and an indicator light. When an outrigger beam is inserted into a port, the switch is closed, and the indicator light illuminates for that port. All four switches must be closed in order to operate the man-lift. Investigators determined that the metal blocks that were inserted into the outrigger ports to bypass the safety interlocks were not standard equipment.

**Figure 4-1. Portable Personnel Lift  
(Courtesy UpRight, Incorporated)<sup>5</sup>**

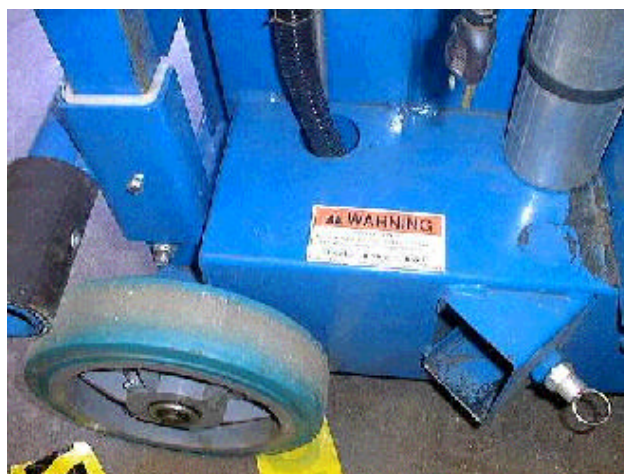
**Figure 4-2. Portable Personnel Lift Outrigger Port  
(Courtesy Los Alamos National Laboratory)**

The facility manager held a critique. Attendees determined that the outriggers were not delivered to the work site with the man-lift. They also determined that the blocks the fitters used to override the interlocks were delivered to the work site along with the man-lift and that the man-lift had probably been operated with the interlocks bypassed on other occasions. Attendees determined that the fitters had attended man-lift operation training and knew that using the man-lift without the outriggers installed was prohibited. Investigators also determined that stickers

near each outrigger port and the operating manual stored on the man-lift warn against operating the man-lift without its outriggers installed. They determined that the fitter had been working with the platform about 6 feet above the floor and that the platform for this class of man-lift can be raised to heights exceeding 25 feet. The investigation is continuing and corrective actions will be developed based on investigation results.

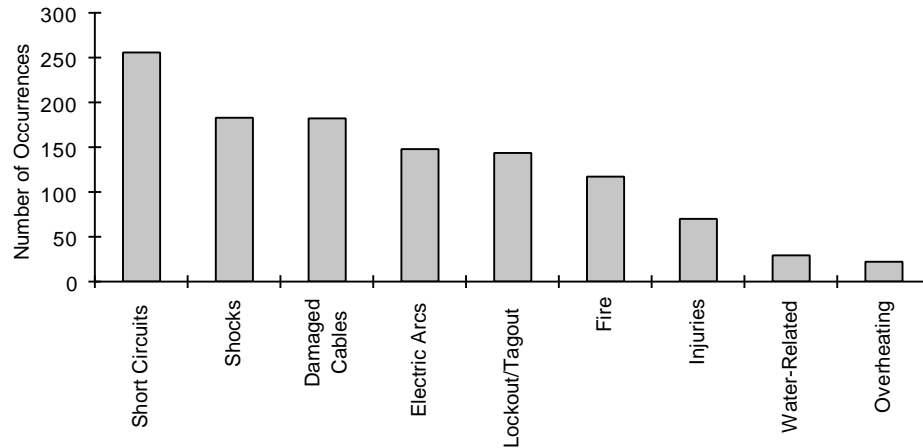
OEAF engineers reviewed selected occurrences from the ORPS database from October 1, 1990, through March 31, 1998, for reports that involved hazardous electrical occurrences and found 794 reports. We determined that each occurrence fell into at least one of the categories shown in Figure 6-1. We determined that short circuits, shocks, and damaged cables were the most prevalent types of hazardous electrical occurrences. Overheating and water-related events were determined to be the least prevalent types of hazardous electrical occurrences.

**Figure 6-1. Types of Hazardous Electrical Occurrences<sup>6</sup>**
